# Technical Bulletin

0416

Actuator Operational Life Cycle - Issue 6

| <b>Product Group:</b> | Patient Lifters | <b>Model(s) Affected:</b> | All Classic & Pro Series Lifts (Elec) |

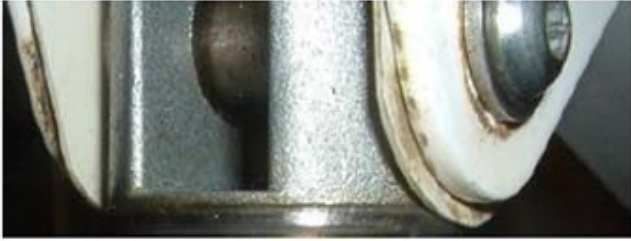
Photo 1

- Examine the actuator mounting points on the boom and the mast (see Photo 1) on the attached pictorial guide.
- Without taking the mountings apart, check for signs of wear on the fulcrum pin (see Photo 6).
- Check for excessive vertical and horizontal movement in the mountings (see Photo 6).

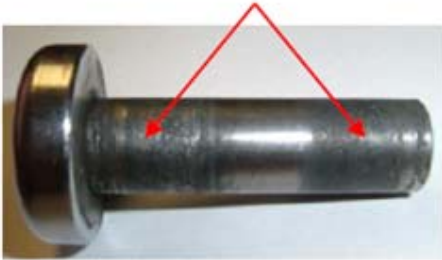
1. Remove the fulcrum pin from the actuator bracket.
2. Examine the pin for signs of wear (see Photo 2 on next page).
3. Reduction in diameter due to **wear must not exceed 1mm before replacement of the pin.**
4. Examine the actuator mounting brackets on the boom and mast for wear on the mounting holes. **These should not exceed a 2mm elongation in any direction before replacement of the mast or boom** (see Photo 3 on next page).
5. Examine the actuator top and bottom mounting points for wear. **It should not exceed 1mm before replacement of the actuator** (see Photos 4 & 5 on next page).
